**Subsidence Documentation Study**  
**Sufco Mine**  
**May 30, 2003**  
**Summary**

The data contained in this binder is a compilation of subsidence features gathered in the field from the 19 of May to the 22 of May 2003. The features have been organized into five different sections representing panels in descending order starting with the most recent. At the beginning of each section is a summary sheet outlining important aspects of the panel with emphasis on subsidence features contained therein.

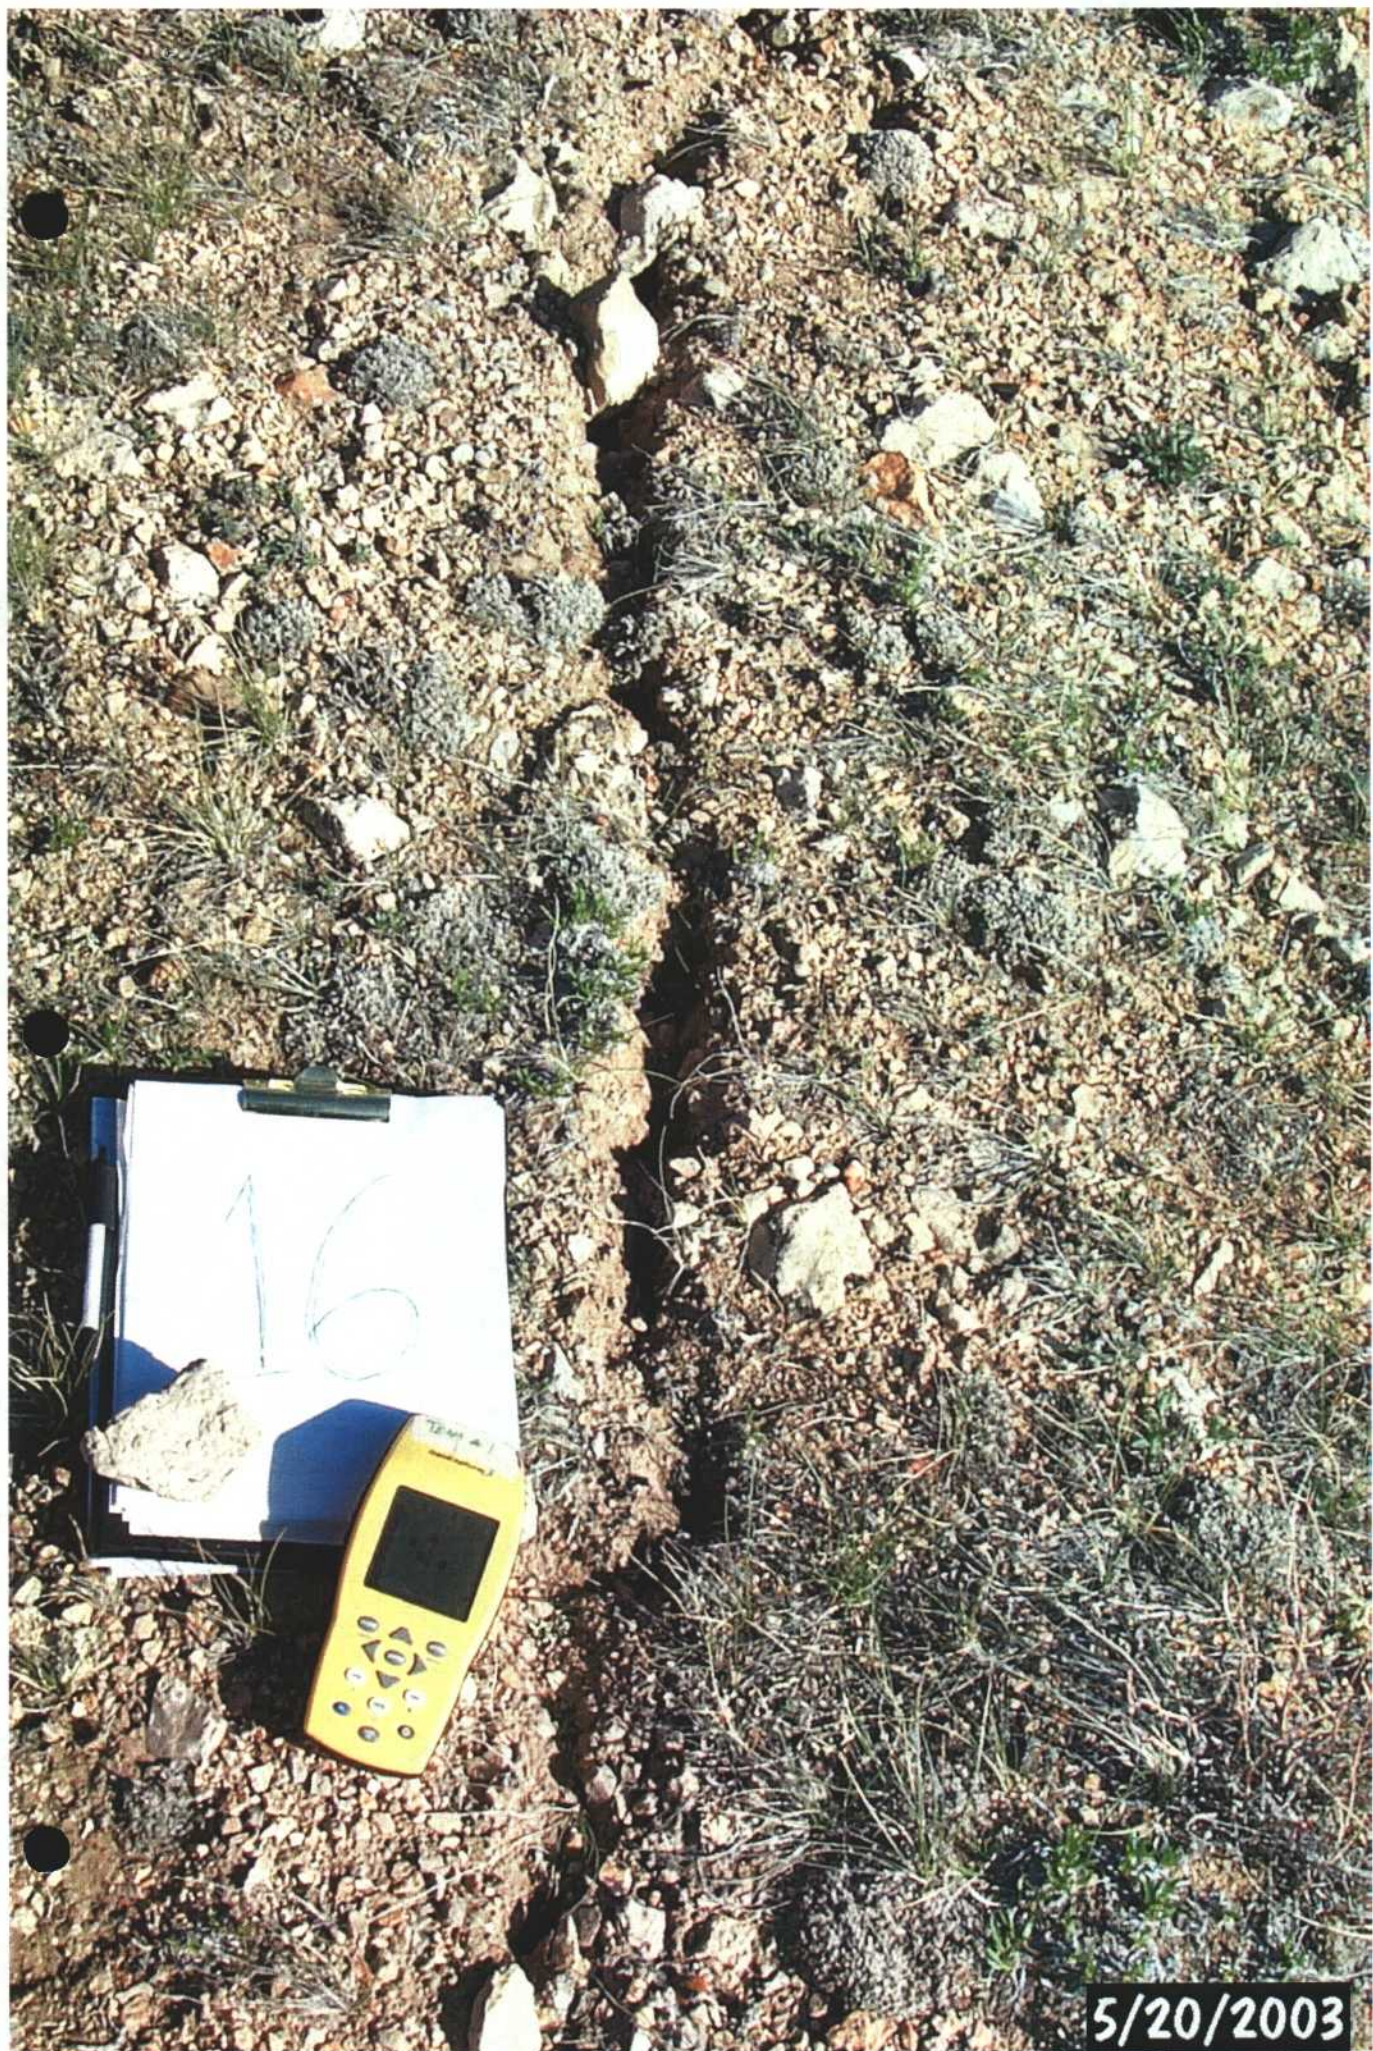
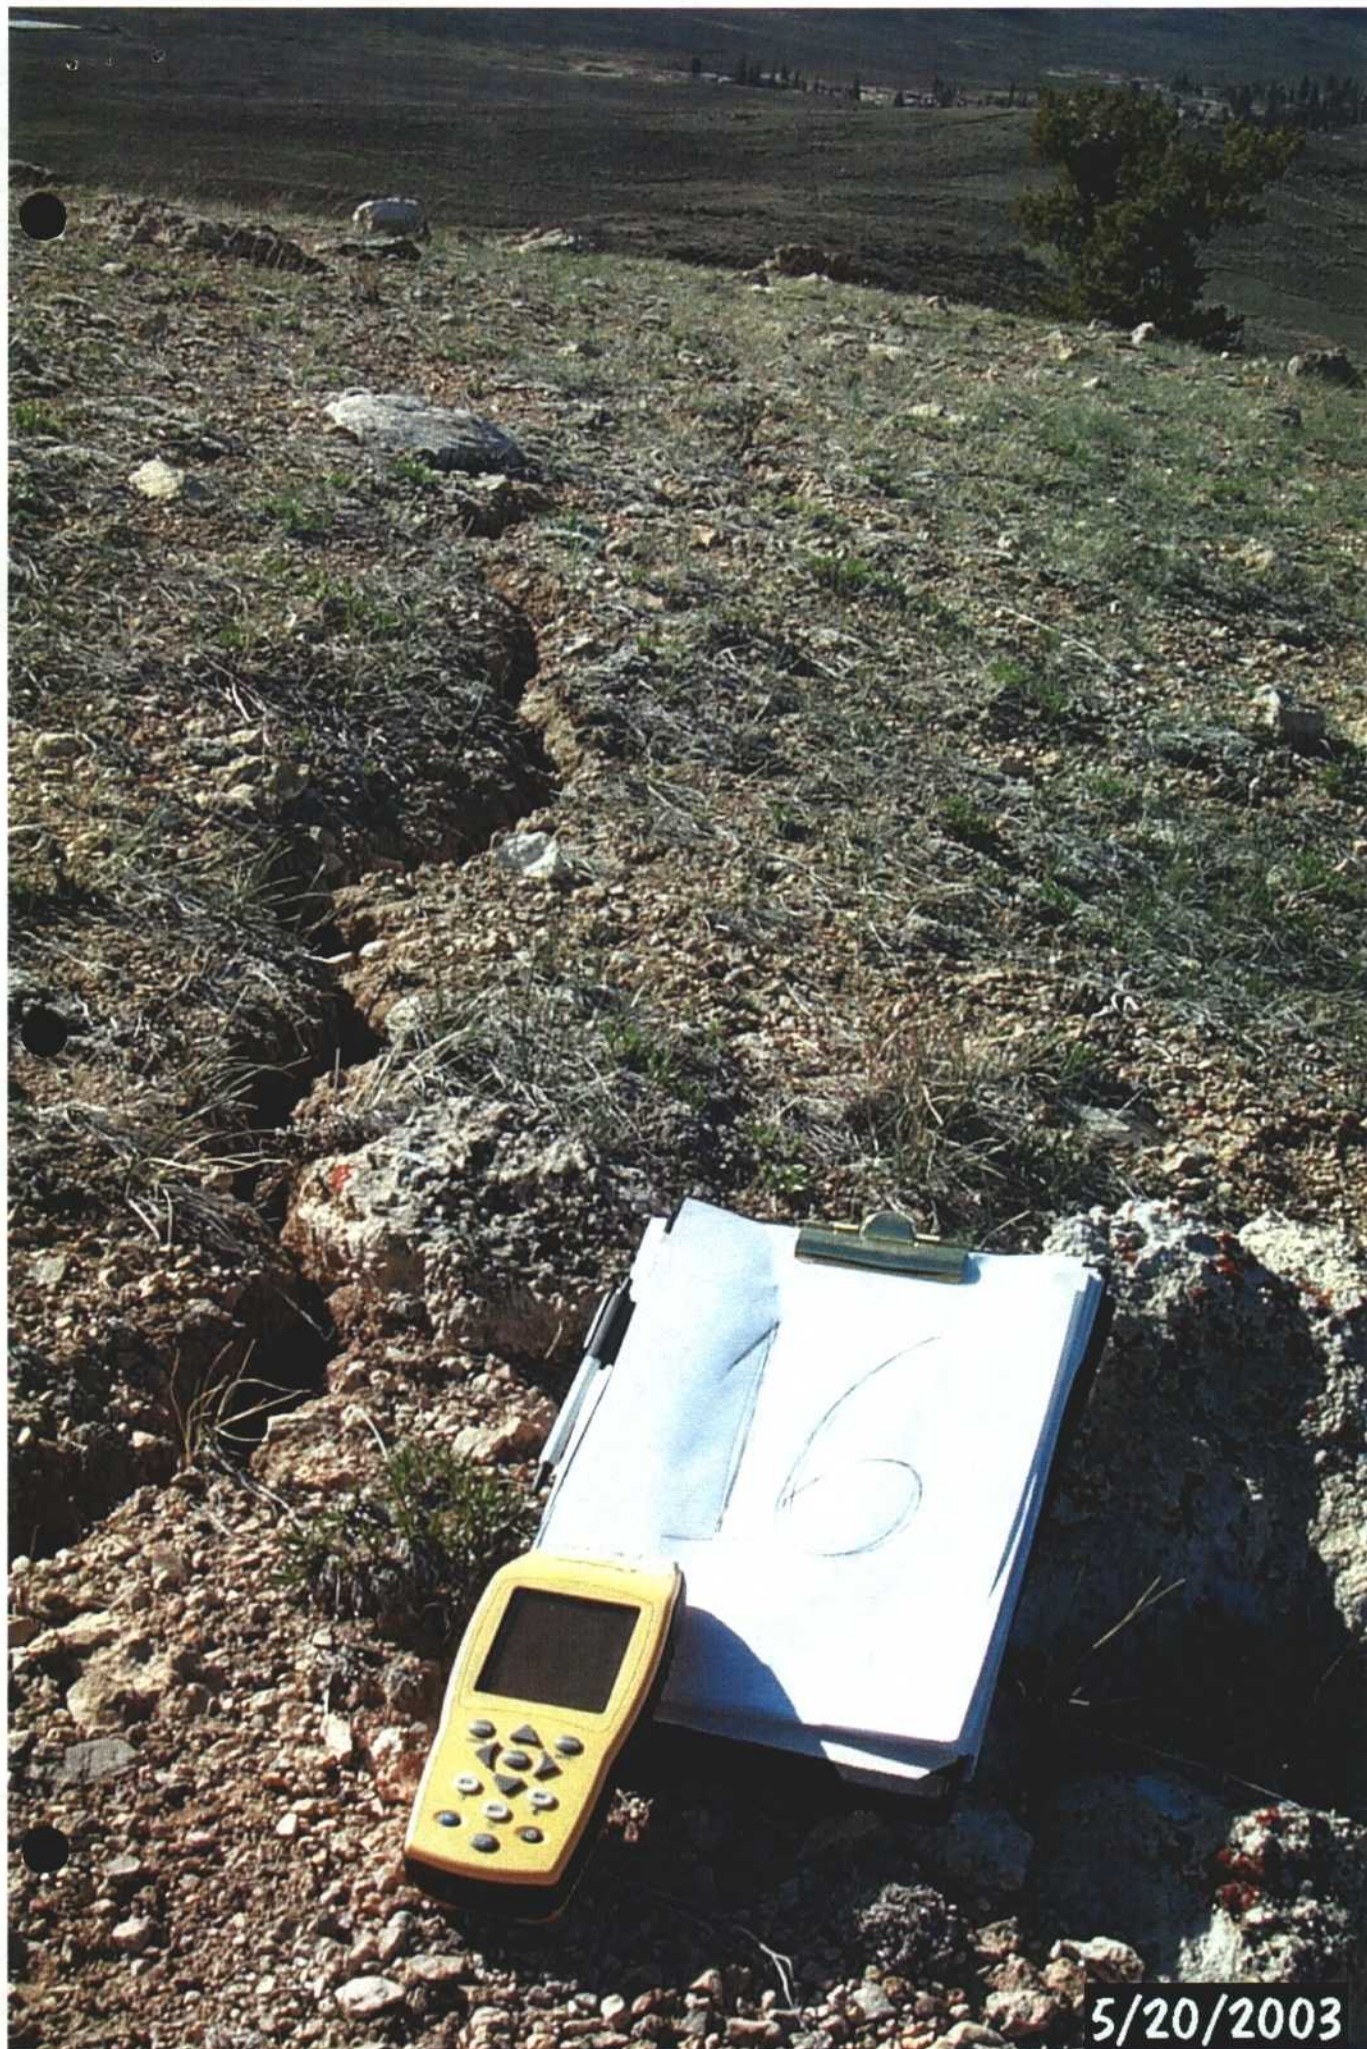
**Dimensions (in feet):** This crack is 148 feet long, and up to 5 inches wide.

This crack is located on the east flank of the Wildcat Knolls, and appears to be healing well, although I would watch this one to ensure that it doesn't get as large as feature #18, which lies adjacent.

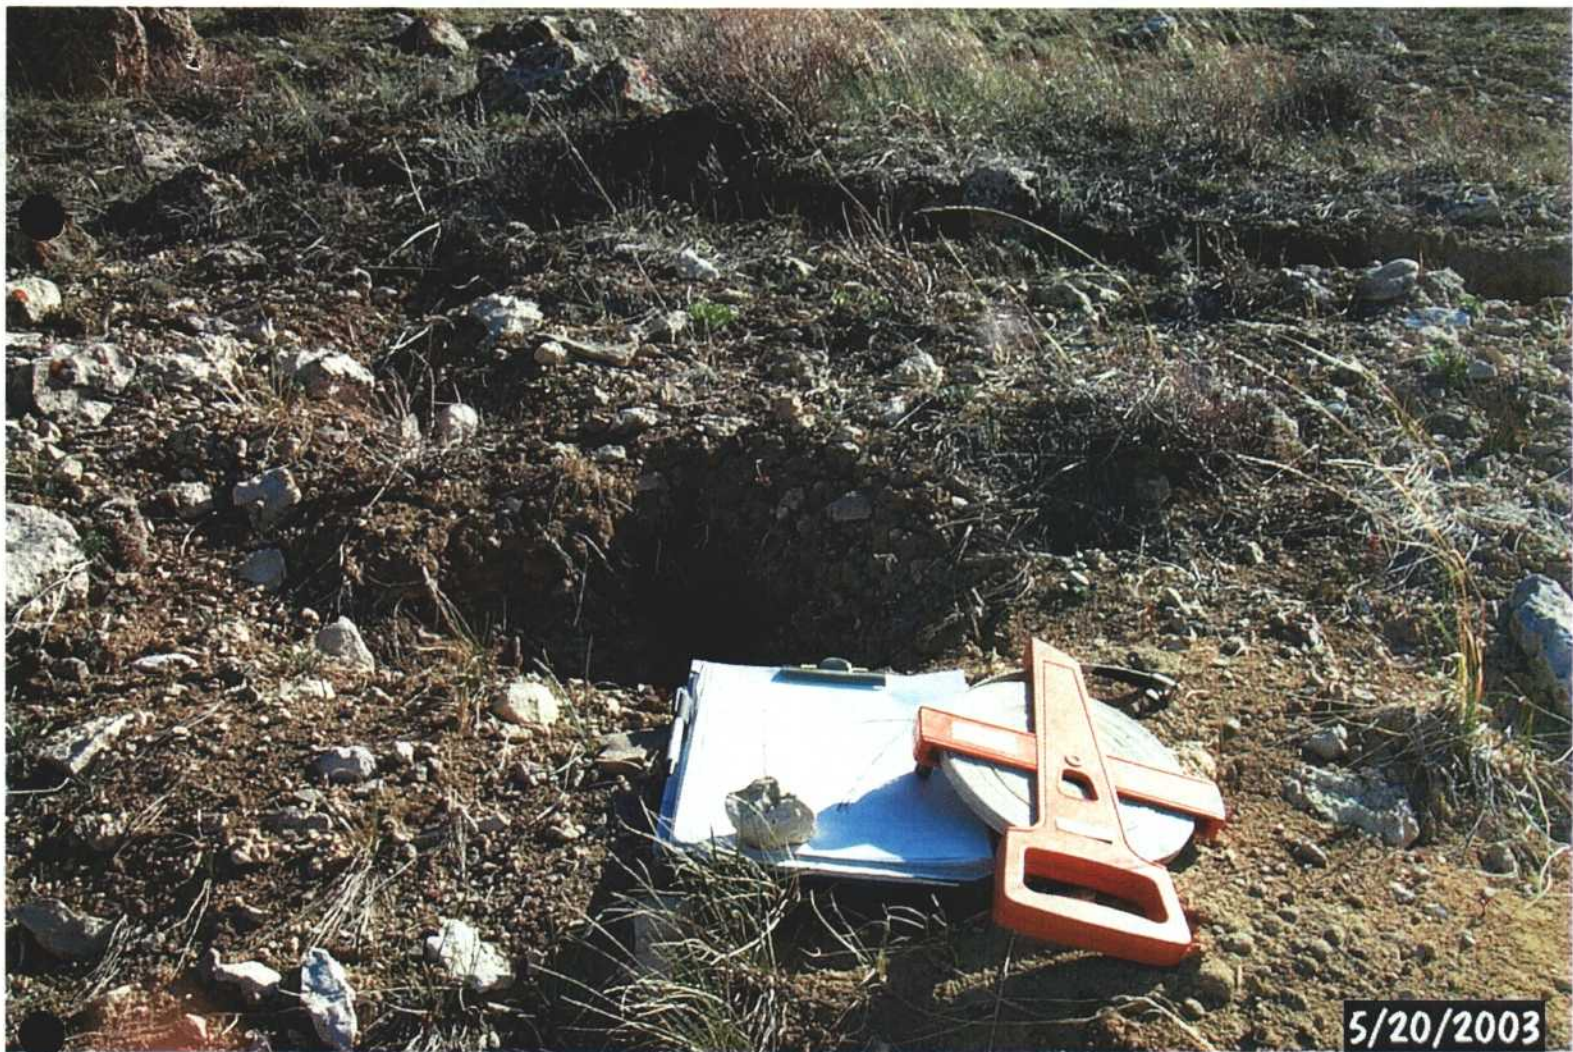
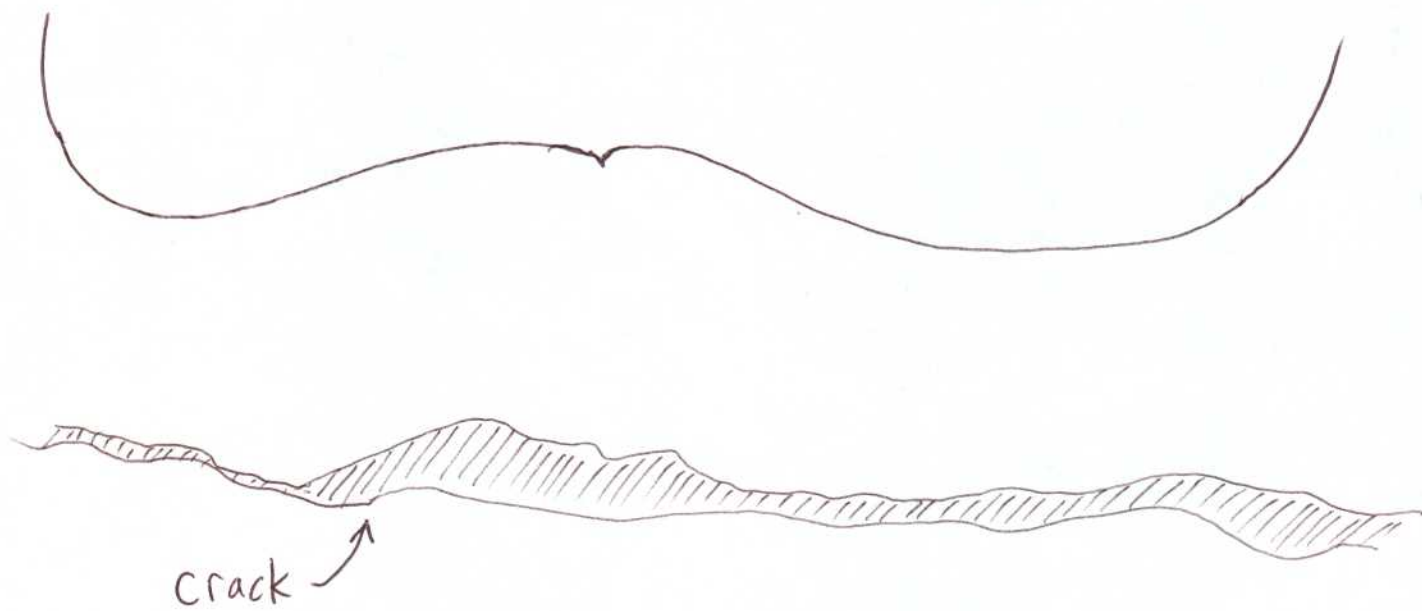
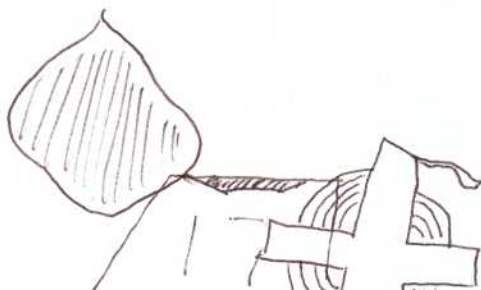
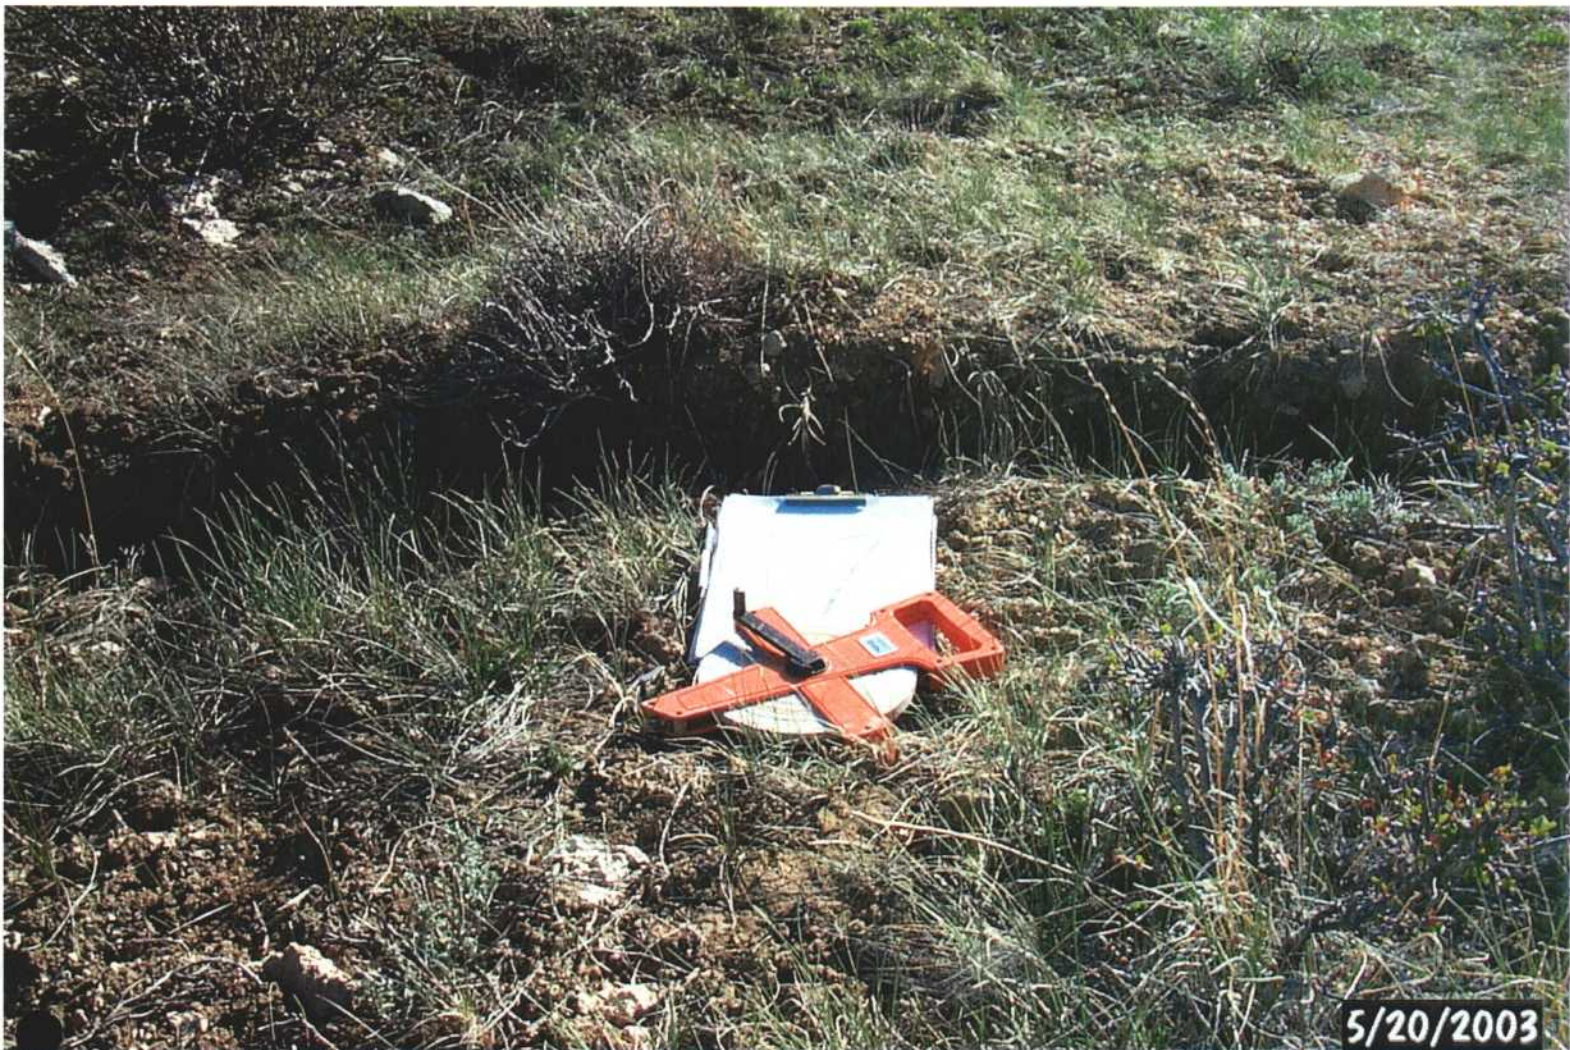
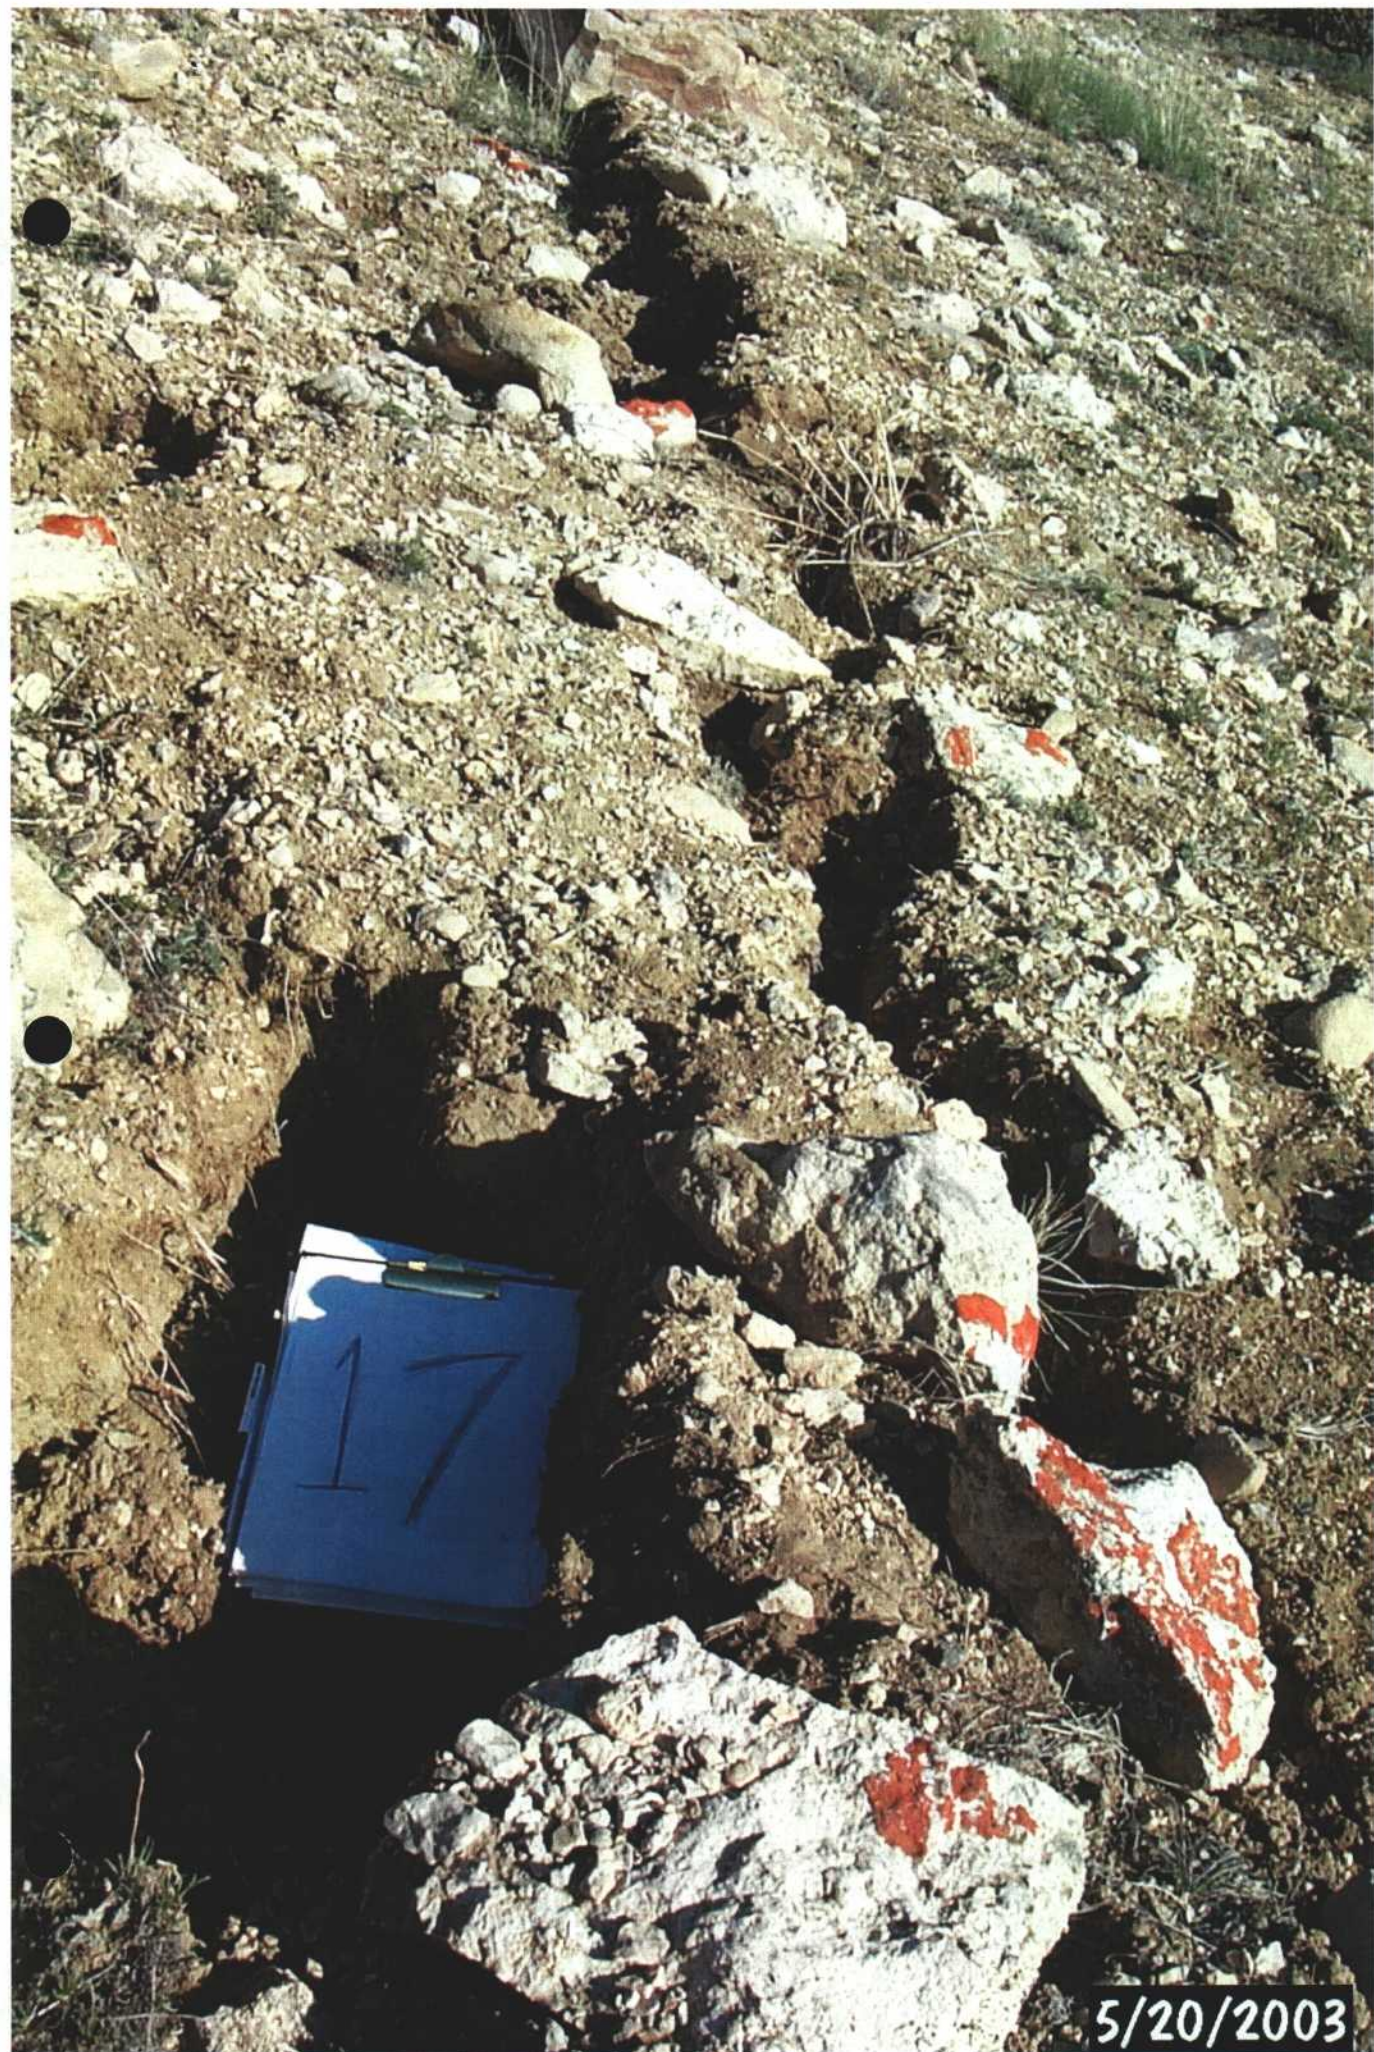
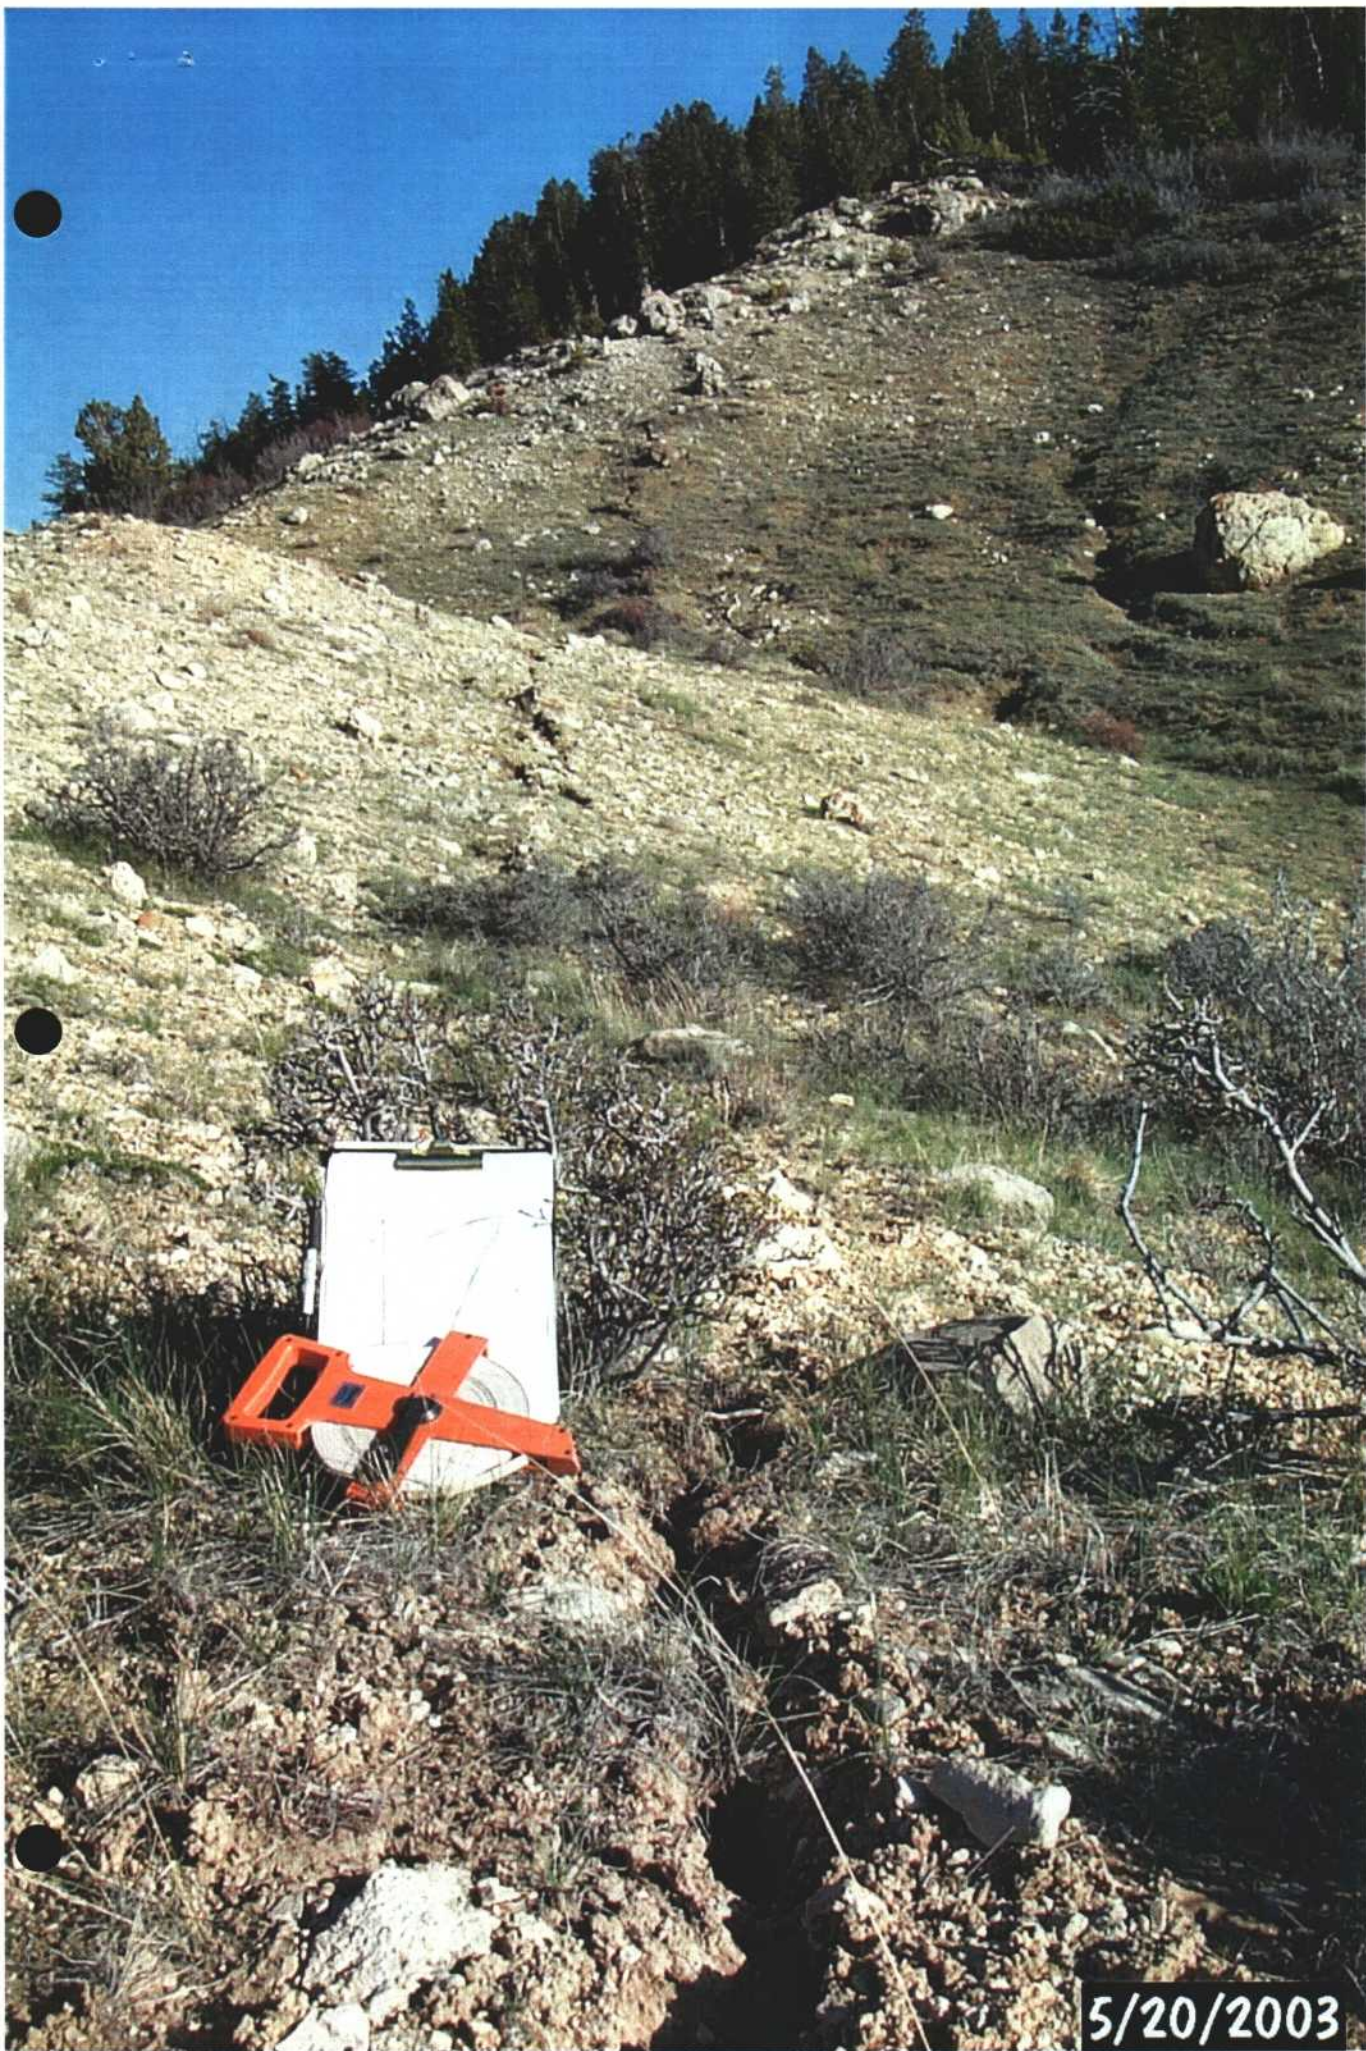
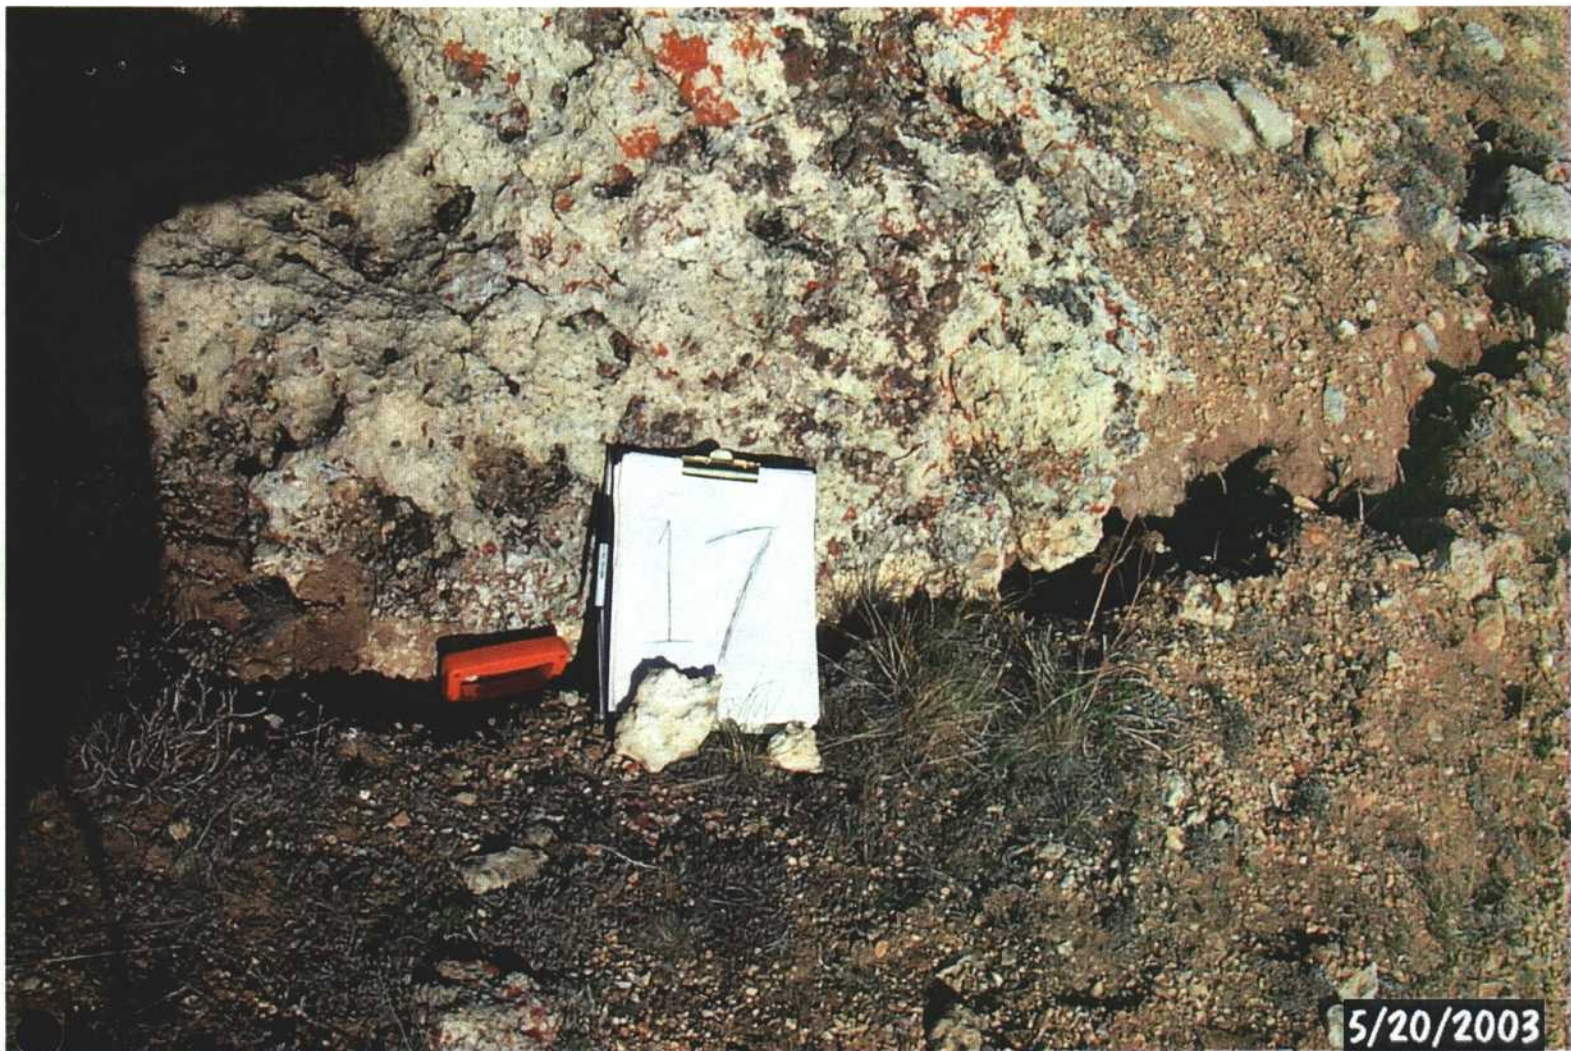
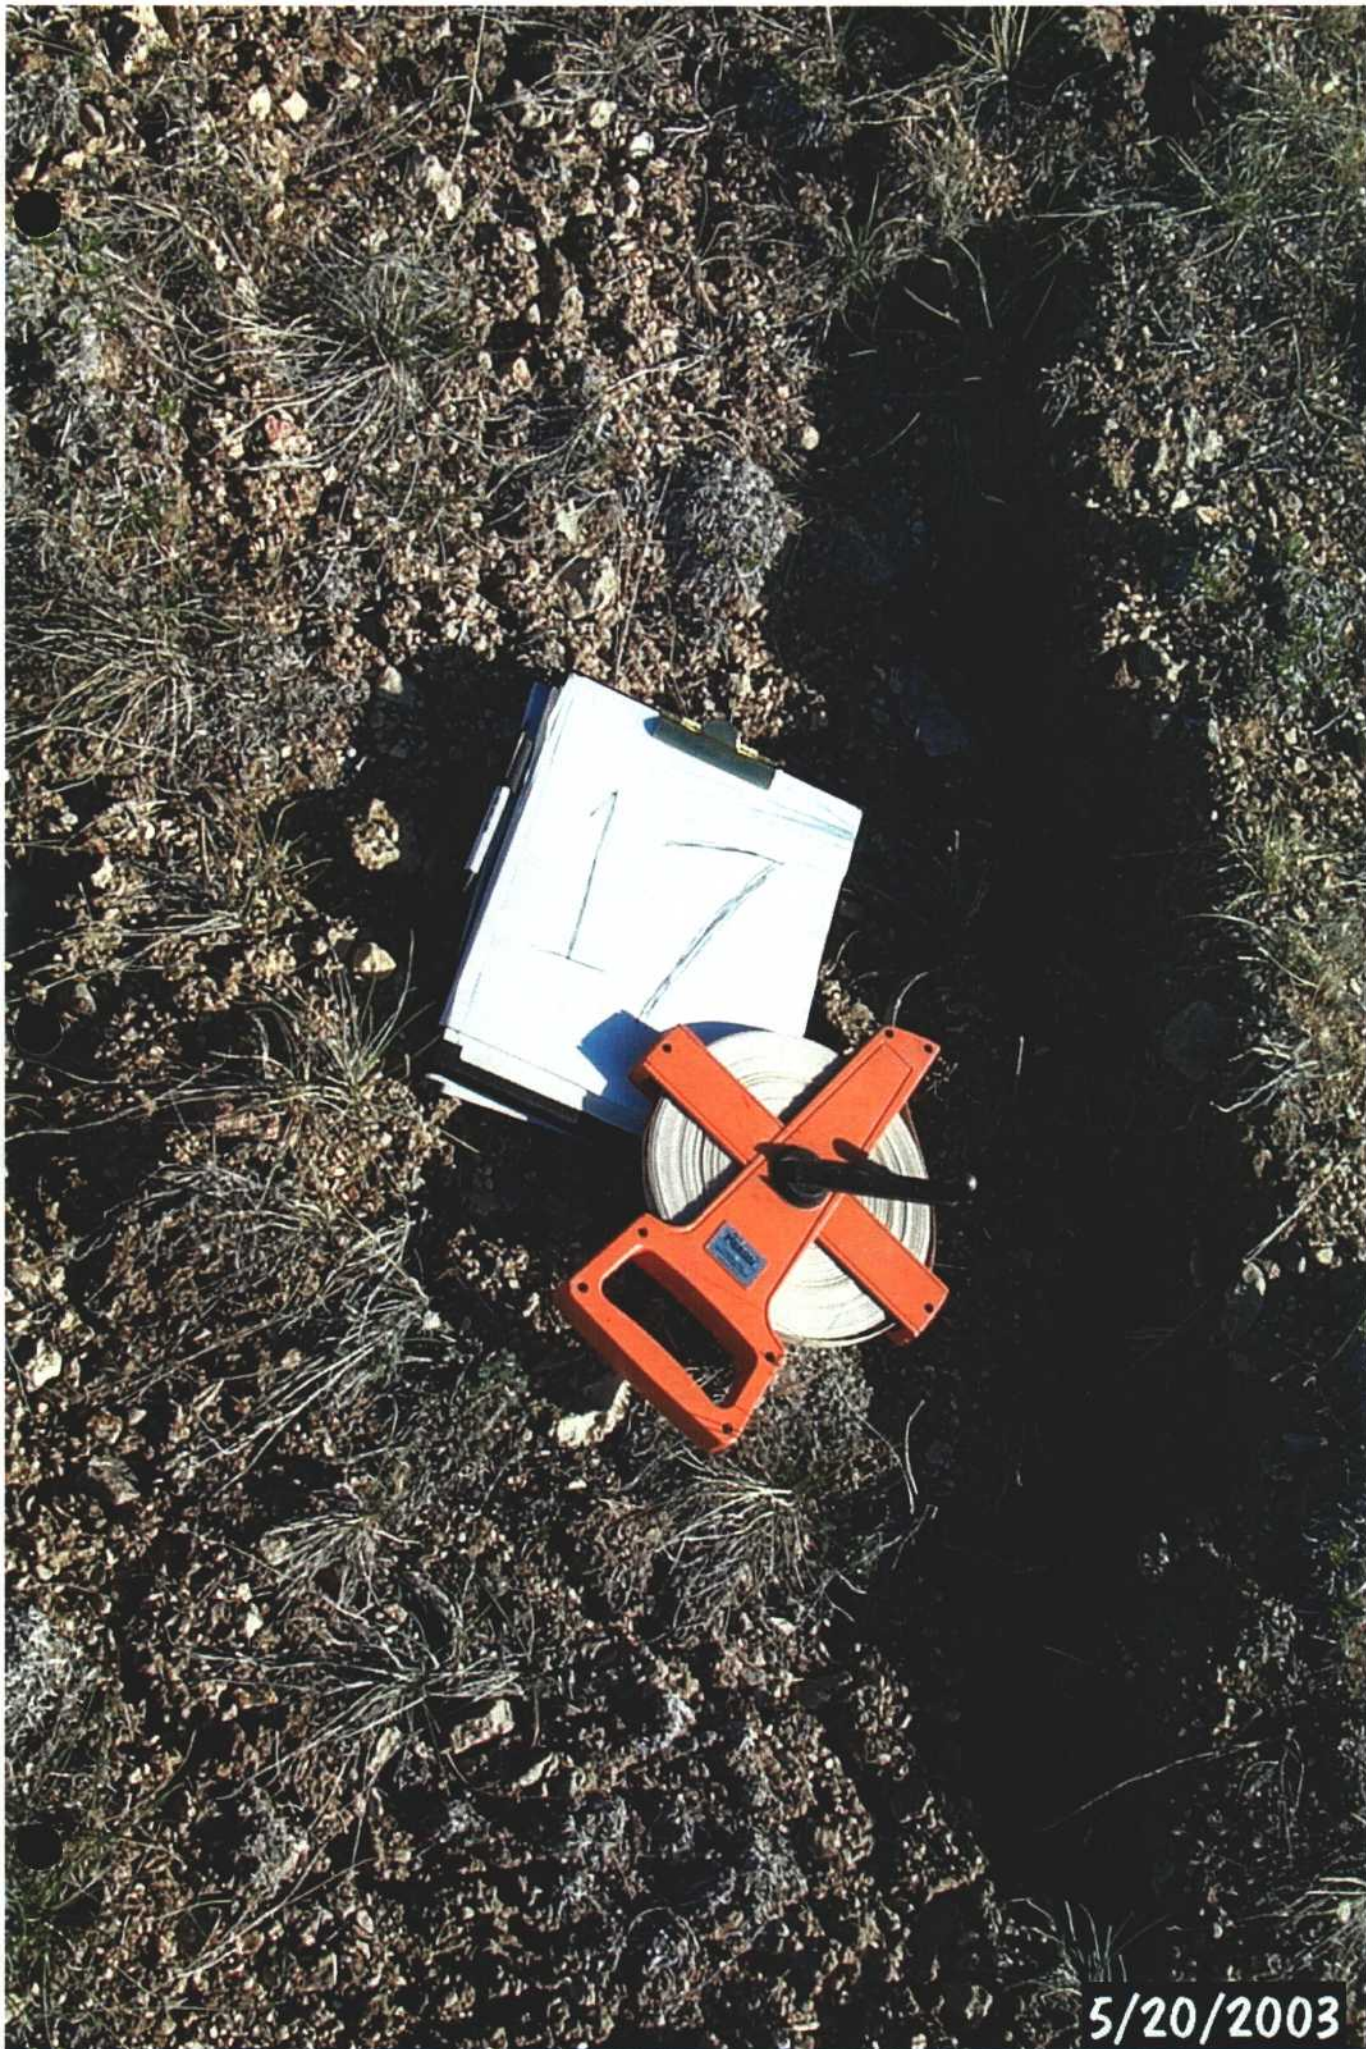
Dimensions (in feet): This crack is 500 feet long. It is up to 2 feet wide in places, with as much as 11 inches of vertical offset. It appears quite deep in most places.

Potential Hazards? A potential threat to cattle, unwary hikers, and possibly to whatever burrowing animals that live in this area (see photos).

This crack is healing slowly in places. I would recommend watching this one as it may need mitigation if it doesn't heal quickly or worsens.

Features 16 and 18 should be watched and monitored at a later date to ensure that healing is underway and show no signs of worsening to the point of becoming a hazard. Feature 18 in particular is quite large, and no doubt will take a long time to heal on its own. Mitigation should be considered if the crack widens further.

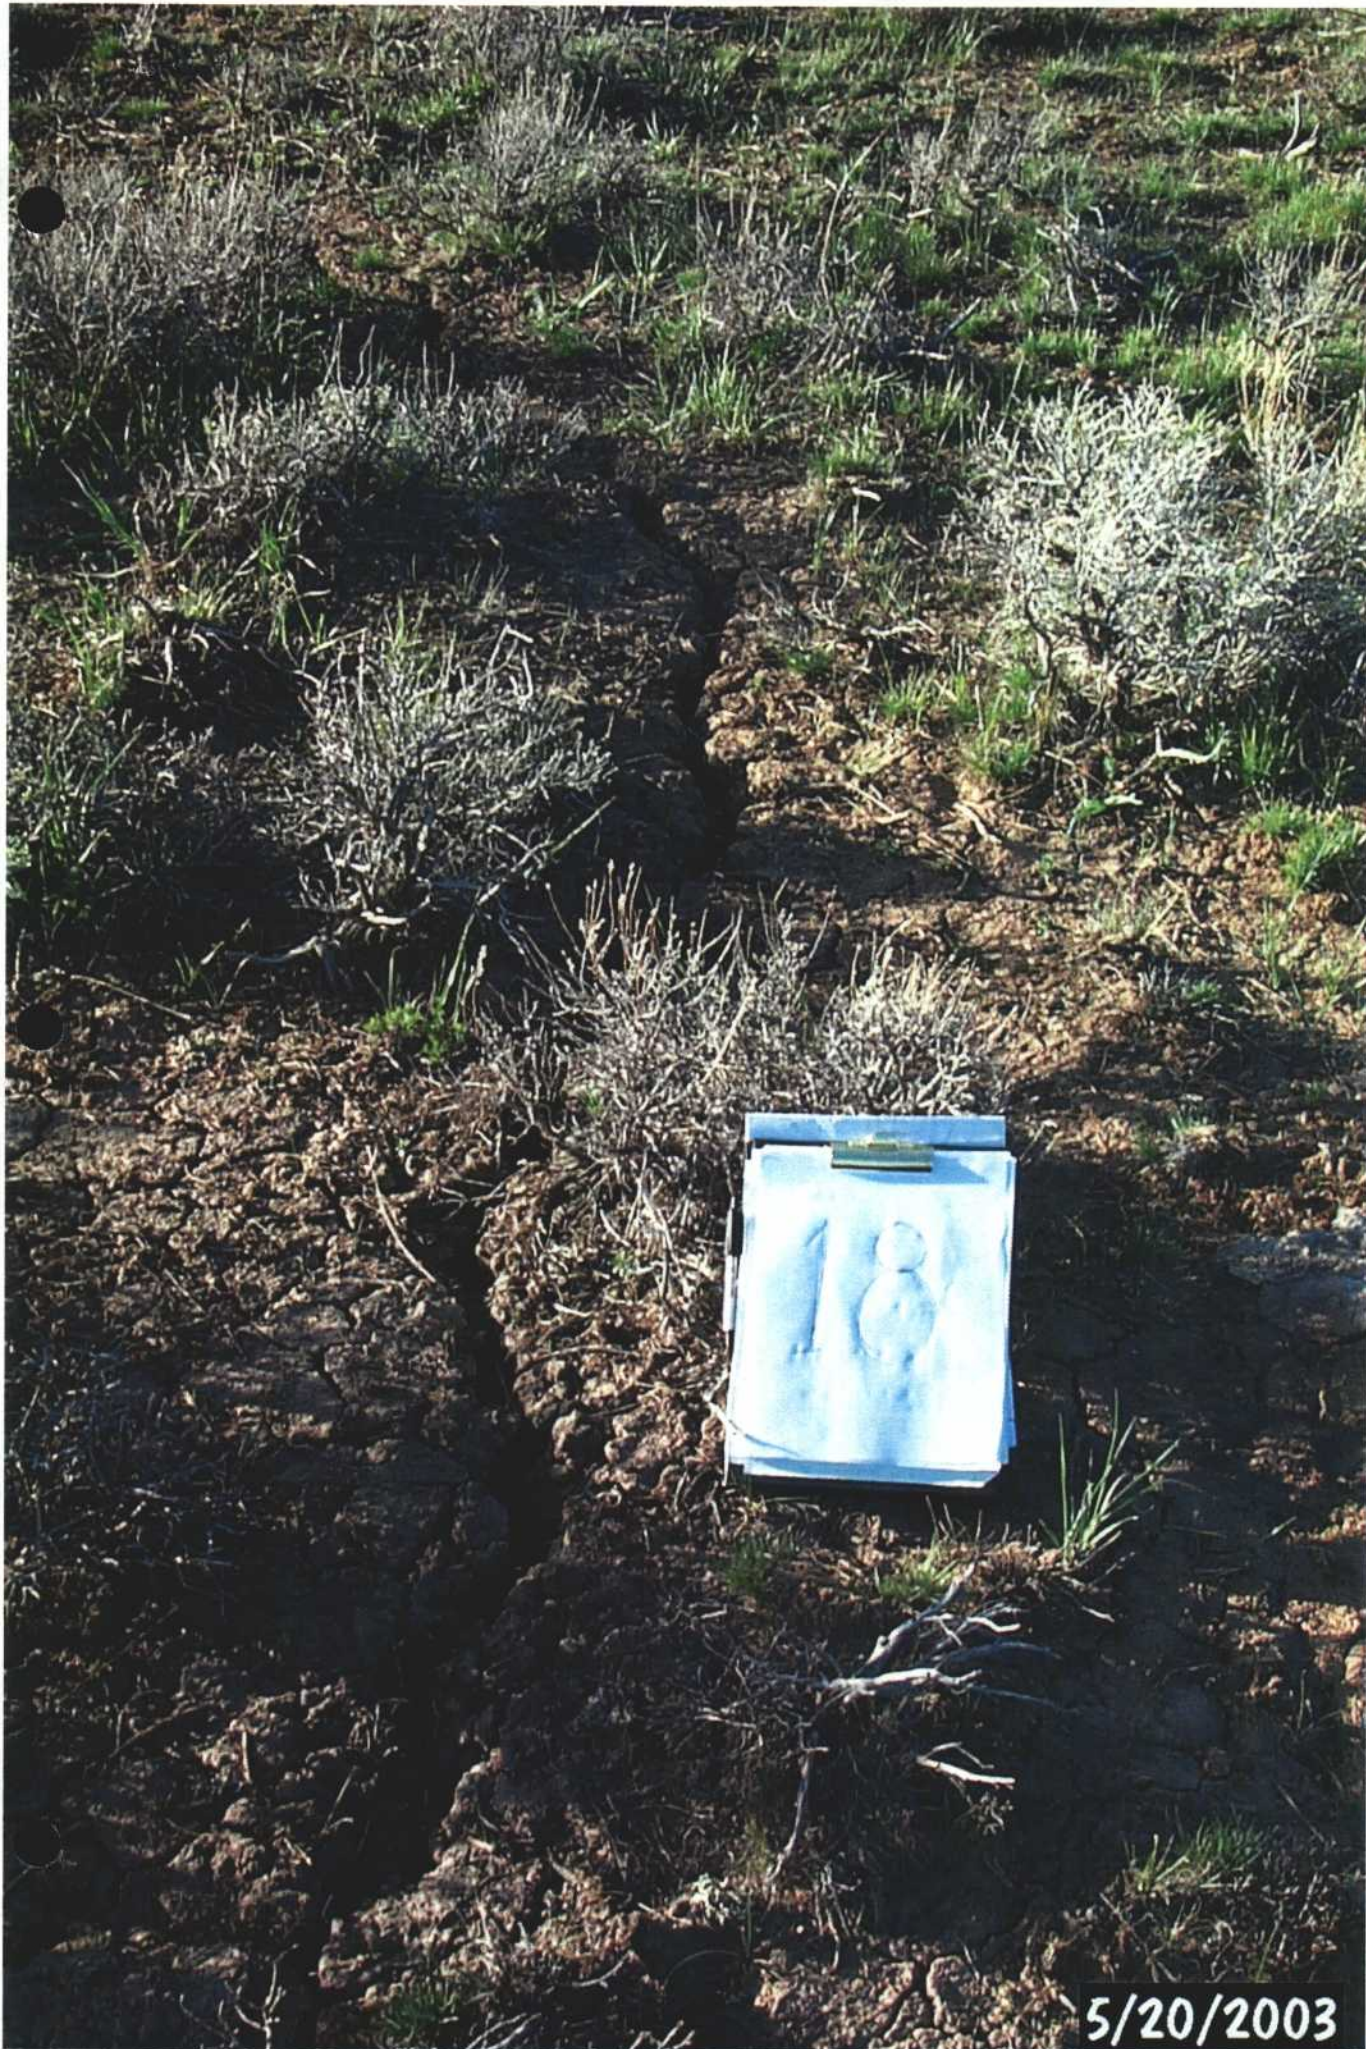
Dimensions (in feet): This crack is 97 feet long. Width varies from 1 to 4 inches.

This crack is healing quite well.
